Manhole Inspection Summary

Manhole # S27I__044MH

Insp Date: **1/16/09 12:34 PM**

Location Address: **Boyd St.**

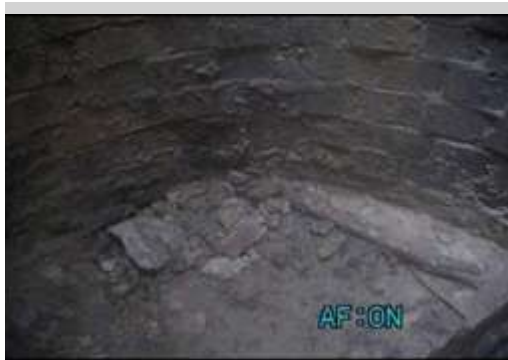
Miscellaneous

debris on bench and barrel infiltration

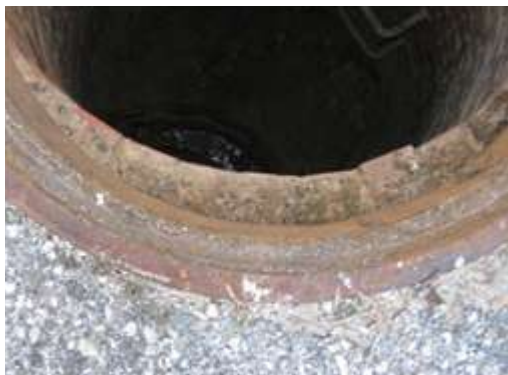
Defect 2

Frame Offset: **2** (in.) Condition: ☒ Sound ☐ Cracked ☐ Leaks

frame offset 2 inches

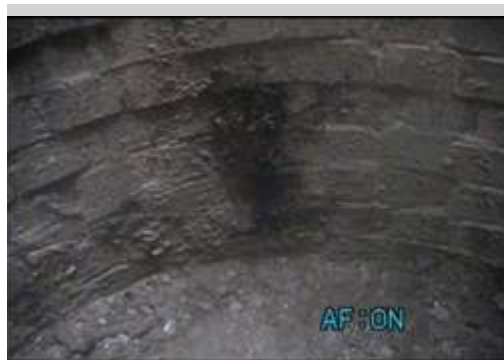
Defect 4

Infiltration: ☐ None ☐ Joint ☐ Cracks ☒ **Mortar** ☐ Roots ☒ **Wall**

barrel infiltration from mortar & wall

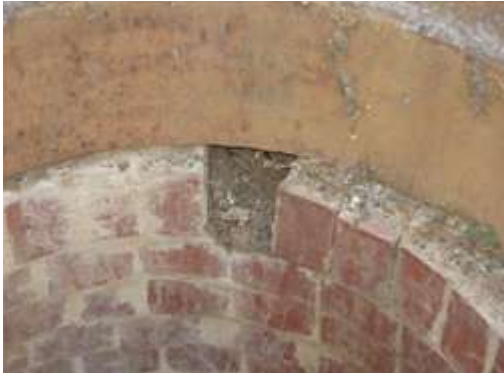
Defect 1

Condition: ☐ Sound ☐ Cracked ☐ Root Intrusion ☒ **Loose Brick** ☒ **Deteriorated**

chimney loose/missing bricks &
deteriorated

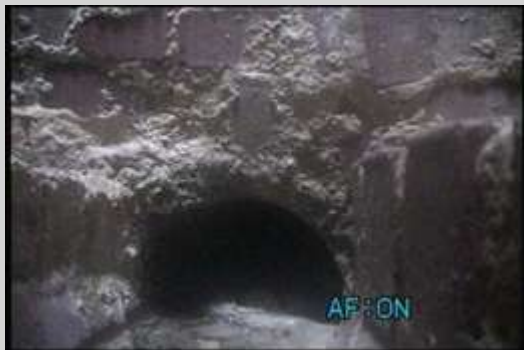
12 O'Clock Outflow

Pipe Height: **7.2** (in.) Rod and Bar (Angled)
Pipe Material: **Clay** ☐ Pipe Lined
Invert Depth: **12.38** (ft.) Flow Characteristics: **Slow**
Deposits: ☒ None ☐ Mud ☐ Sludge ☐ Debris ☐ Grease
Silt Depth: **0** (in.) Deposits Extent:
Infiltration: **None** Pipe Seal Cond: **Sound**

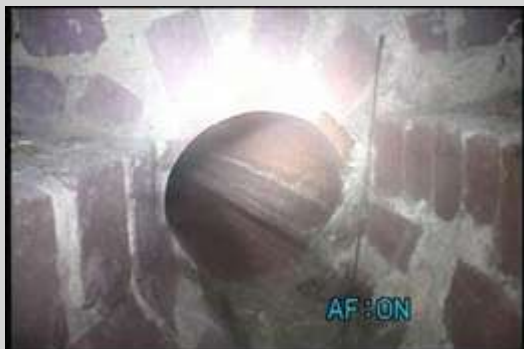
3 O'Clock Inflow

Pipe Height: **8.4** (in.) Rod and Bar (Angled)
Pipe Material: **Clay** ☐ Pipe Lined
Invert Depth: **12.16** (ft.) Flow Characteristics: **Slow**
Deposits: ☒ None ☐ Mud ☐ Sludge ☐ Debris ☐ Grease
Silt Depth: **0** (in.) Deposits Extent:
Infiltration: **None** Pipe Seal Cond: **Sound**
